FRANKLIN RESEARCH CENTER

FRC ON-SITE AIR BAG DEPLOYMENT INVESTIGATION

CASE NO. 90-16

FLEET - 1987 MERCEDES-BENZ 300DT

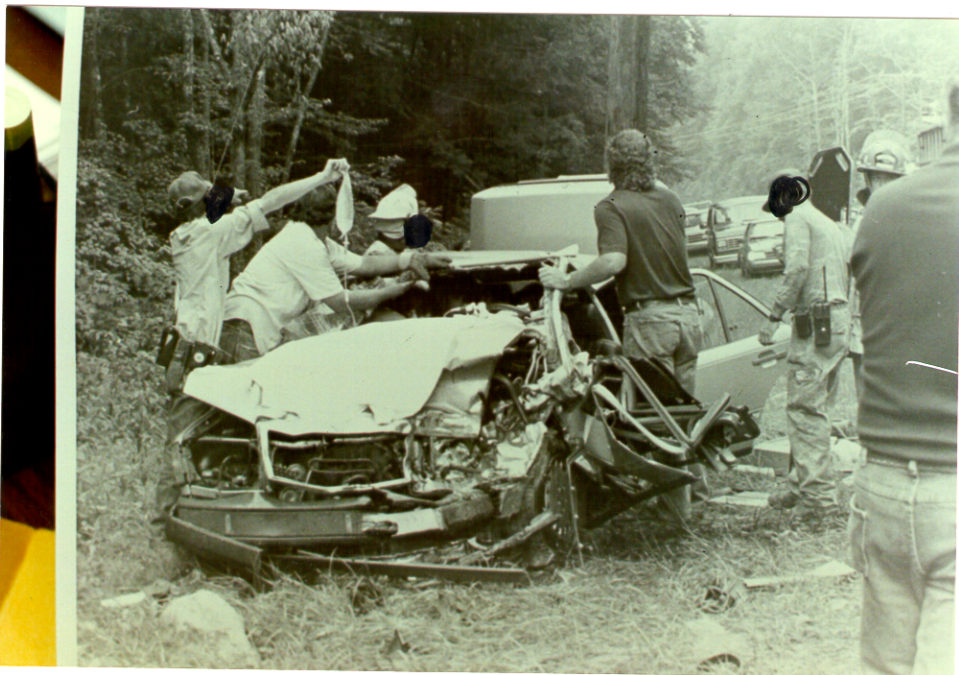
Final Rest Position And Damage To The Mercedes-Benz

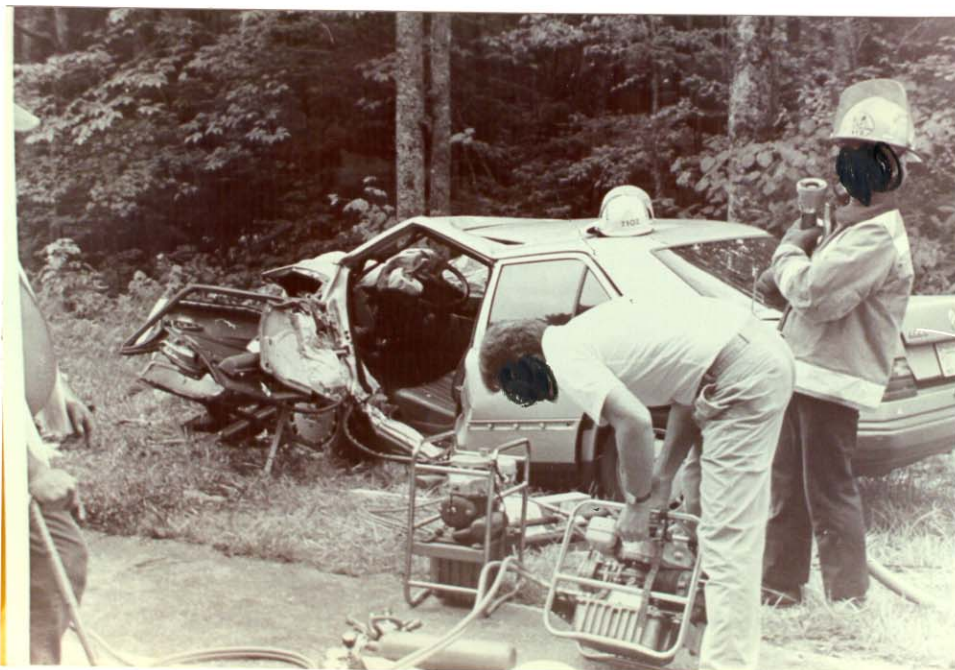
Left Side View Of The Mercedes-Benz At Final Rest

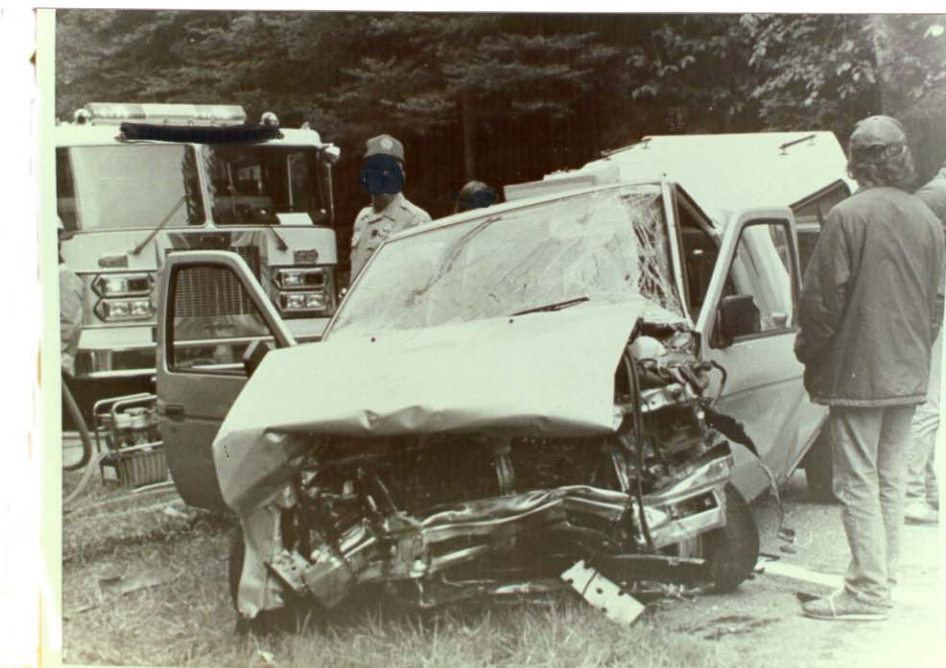
Frontal View Of The Damaged Pickup Truck

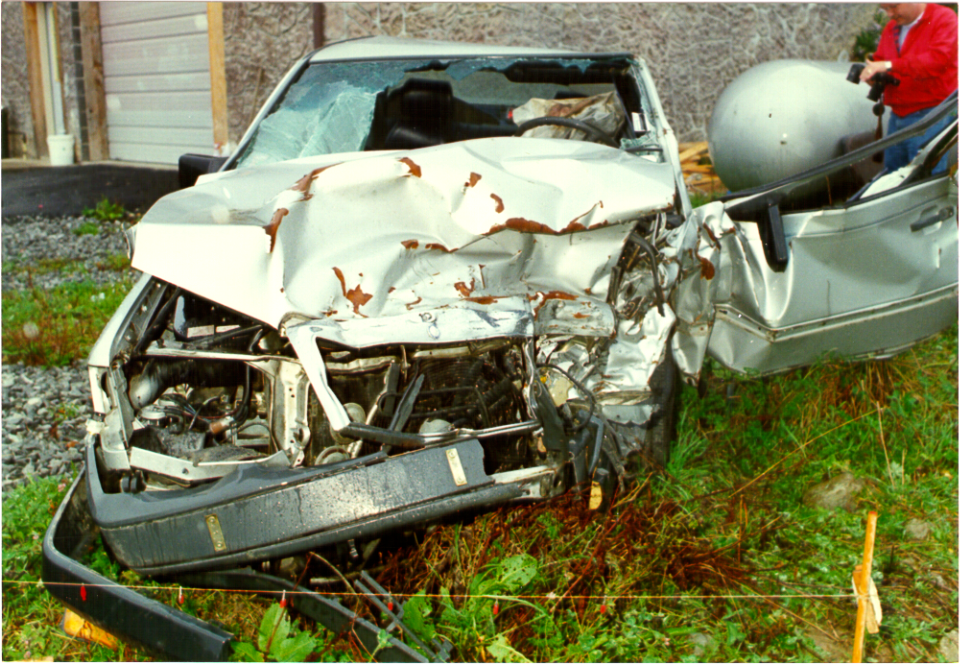
<u>Air Bag Vehicle</u>	<u>Vehicle #2</u>
Exterior:	<p>The frontal area of the Mercedes-Benz sustained severe damage from its impact with vehicle #2. Direct contact damage began at the left front corner and extended 31" to the vehicle's right. The impact displaced the entire frontal area of the vehicle resulting in a combined induced and direct contact damage length of 41". Maximum crush was 33.75" located at the left corner of the bumper reinforcement bar. Crush values measured at the reinforcement bar were as follows: C<sub>1</sub>=33.75", C<sub>2</sub>=20.25", C<sub>3</sub>=14.5", C<sub>4</sub>=6.5", C<sub>5</sub>=1.875", C<sub>6</sub>=1.0".</p>	<p>Primary - The frontal area of the Nissan pickup truck sustained severe damage from its head-on impact sequence with the Mercedes-Benz. Although the vehicle was not inspected, the crush profile was estimated as follows: C<sub>1</sub>=42", C<sub>2</sub>=36", C<sub>3</sub>=30", C<sub>4</sub>=18", C<sub>5</sub>=12", C<sub>6</sub>=8".</p> <p>Secondary - The left front corner initially sideswiped the left side of vehicle #3. The damage was overlapped by the primary impact damage from the air bag vehicle.</p>

Frontal View Of The Mercedes-Benz

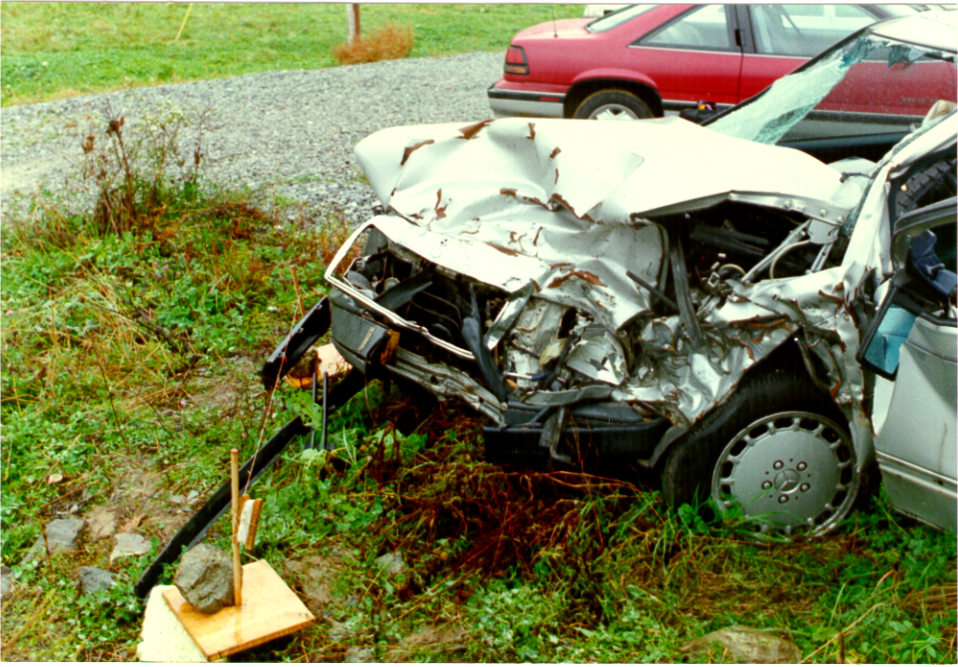
The frontal area of the Nissan pickup truck impacted the left frontal area of the Mercedes in an offset, head-on configuration. The Mercedes sustained 33.75" of crush at the left corner of the bumper reinforcement bar from the 12 o'clock direction of force impact (PDOF: -15°). A velocity change of 26.8 mph was computed by the damage algorithm of the CRASHPC program. As a result of the impact induced deceleration, the Mercedes' SRS system deployed.

Perpendicular View Of The Left Frontal Area Showing  
The Extent Of Crush

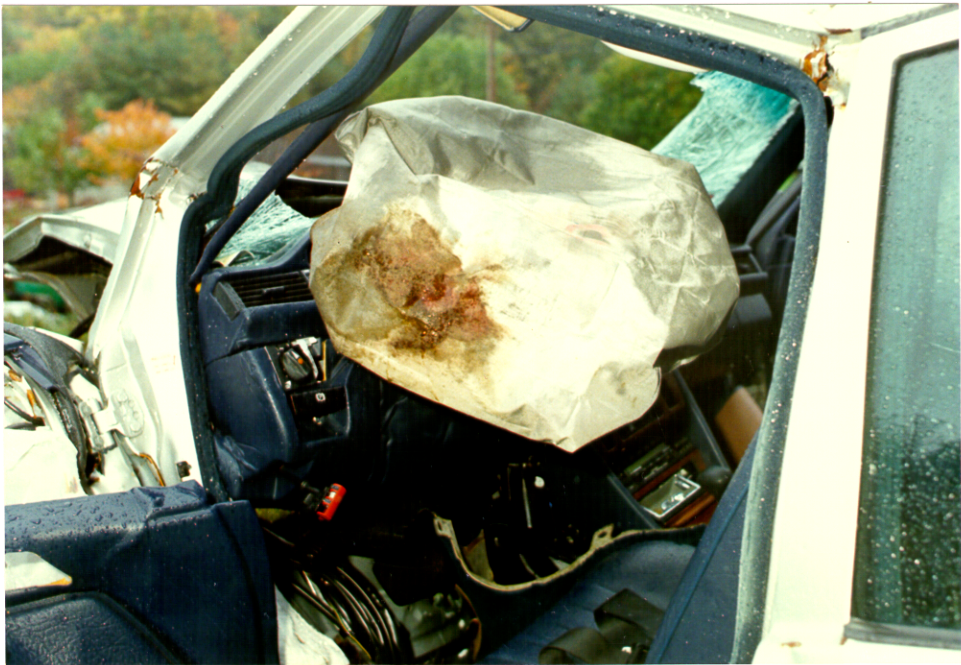
Interior View And The Deployed Air Bag

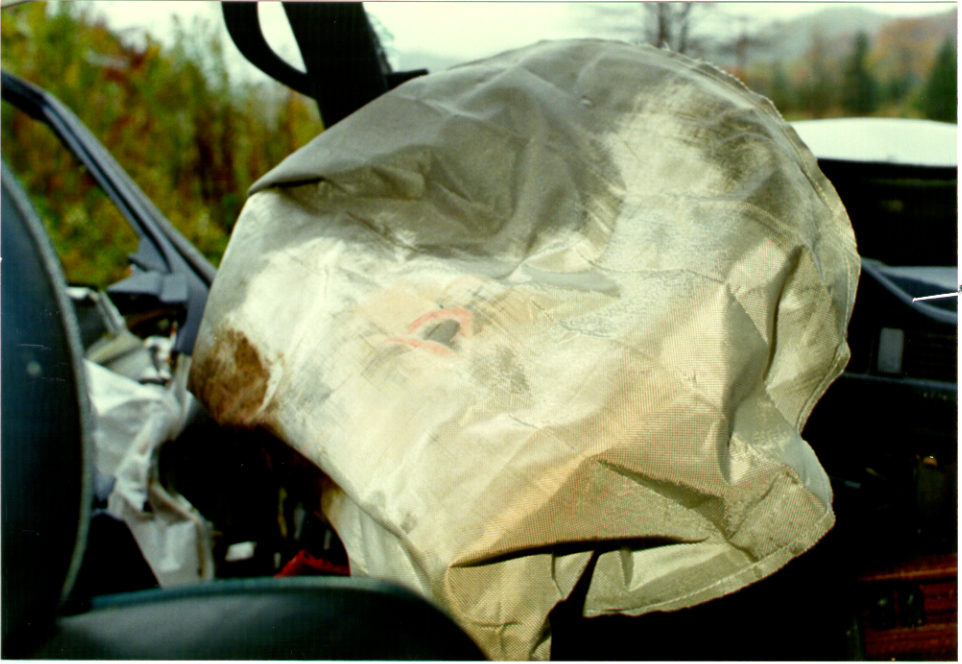
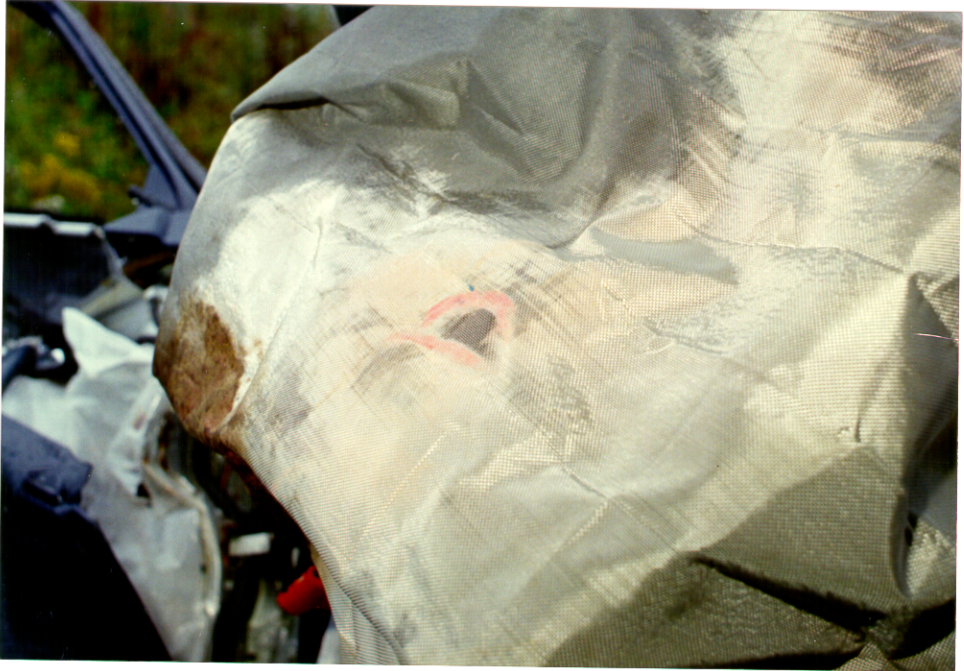
Lipstick And Makeup Transfers On The Deployed Air Bag

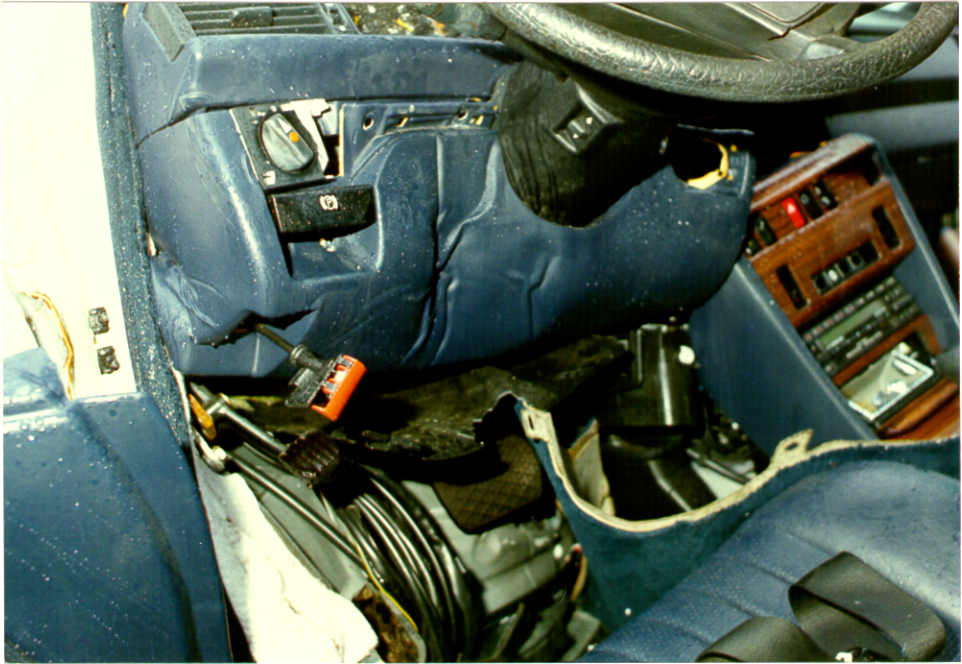
Driver Left Knee Contact To Knee Bolster

Right knee abrasion (AIS-1), knee bolster
